APPENDIX G

Appendix G contains photographs in Plate Nos. 1 to 27 where Plate Nos. 1 to 24 show crack pattern on tension face for specimen nos. 1 to 24, Plate No. 25 shows load testing machine, Plate No. 26 is of specimen MUP 2 4/5 after failure on testing machine and Plate No. 27 shows crushing of concrete on compression face of specimen nos. 13 and 14.

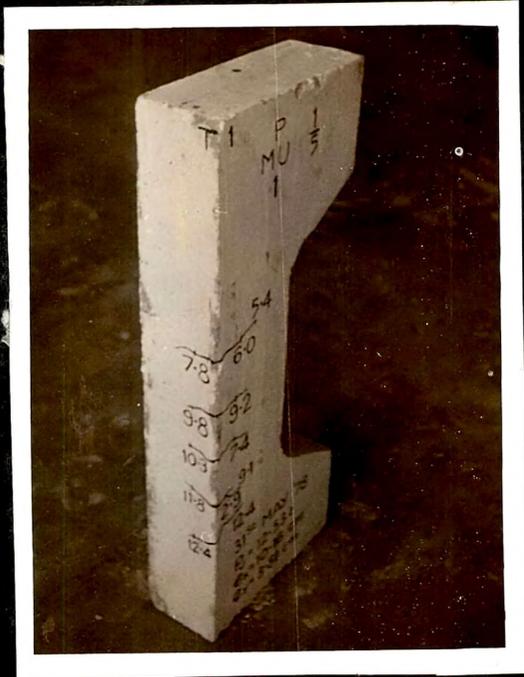
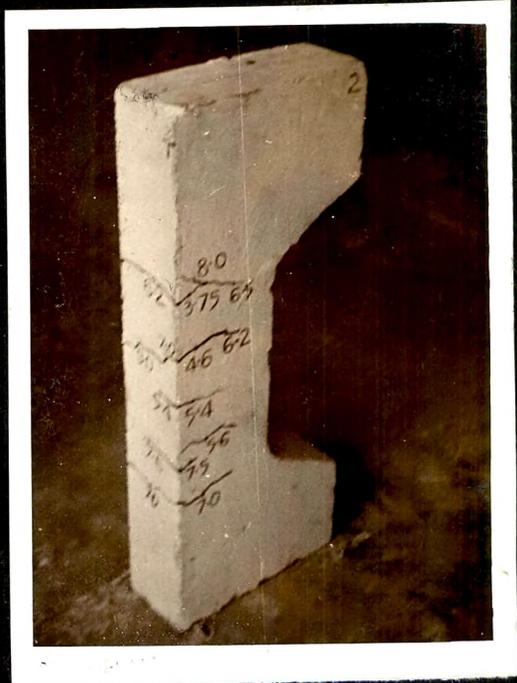
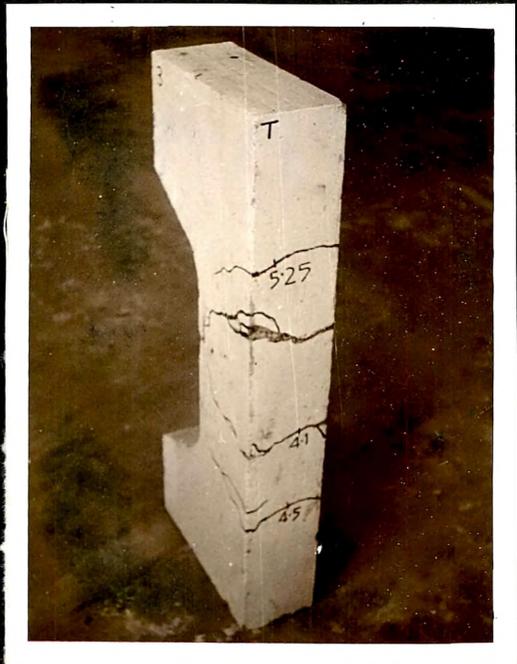
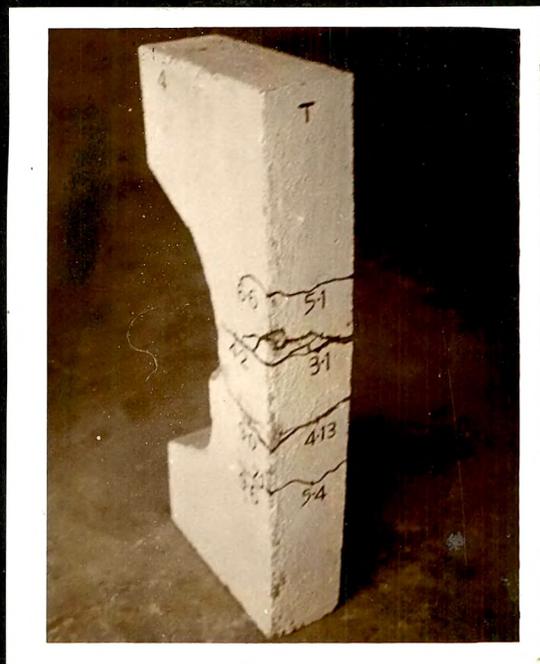
Plate Nos. 1 to 4
Crack Pattern ;
Specimen Nos. 1 to 4

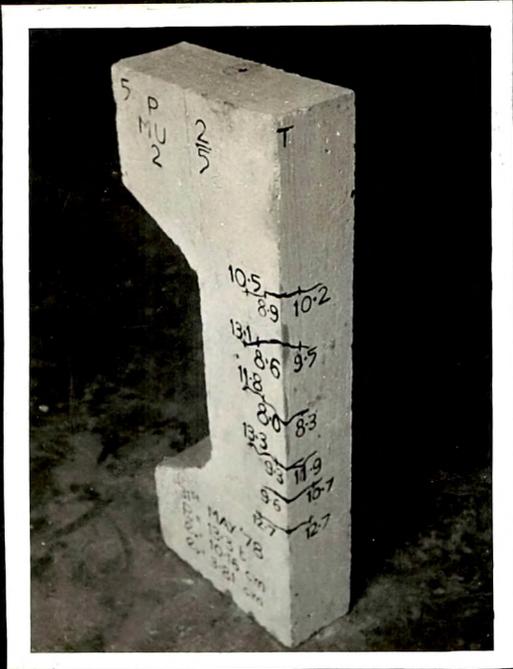
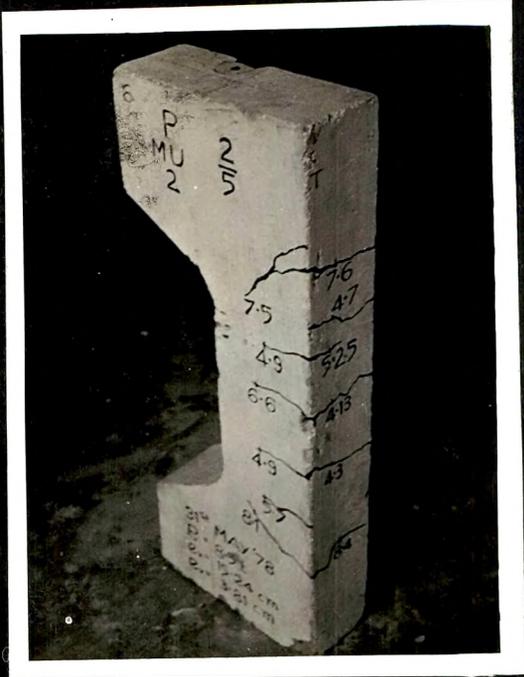
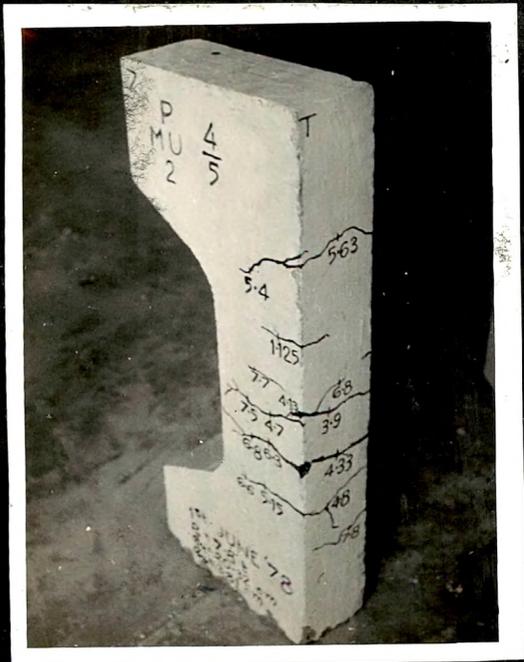
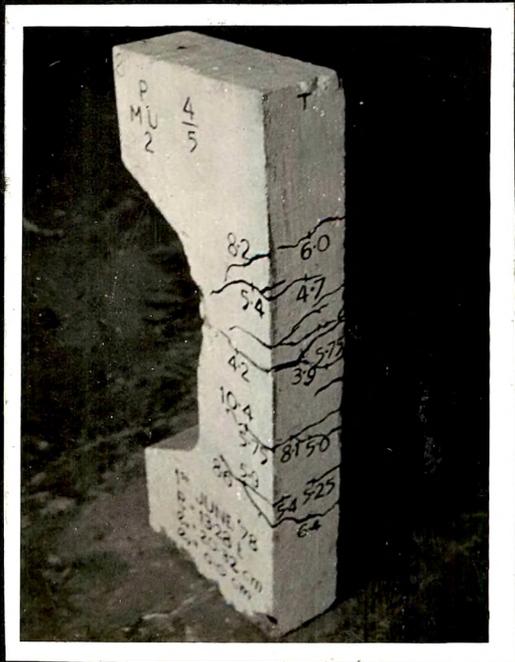
Plate Nos. 5 to 8
Crack Pattern ;
Specimen Nos. 5 to 8

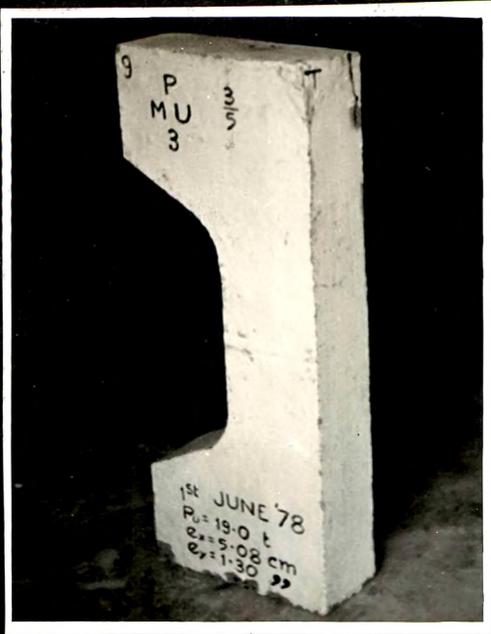
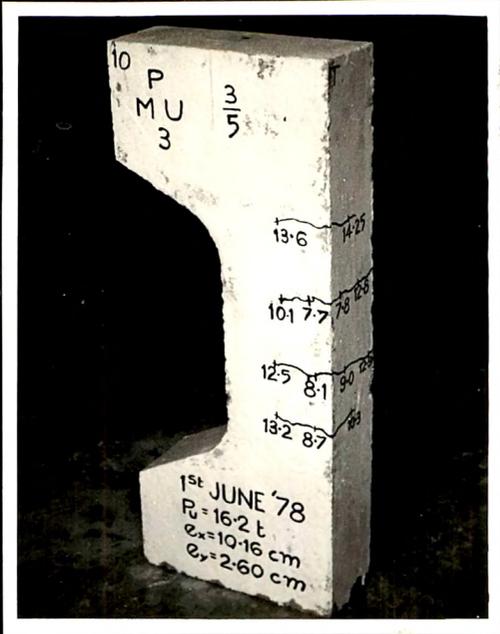
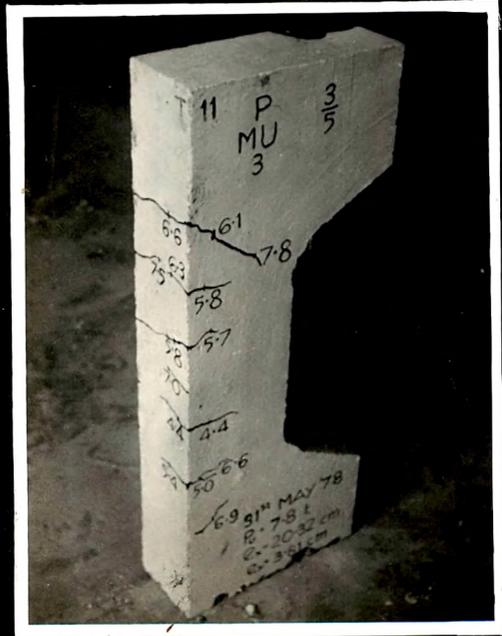
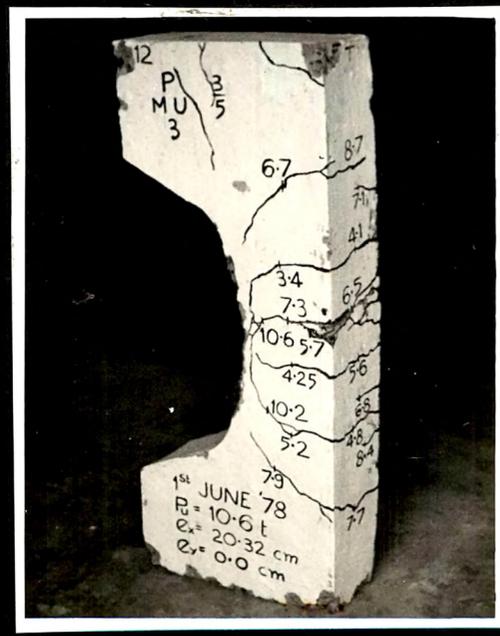
Plate Nos. 9 to 12
Crack Pattern ;
Specimen Nos. 9 to 12

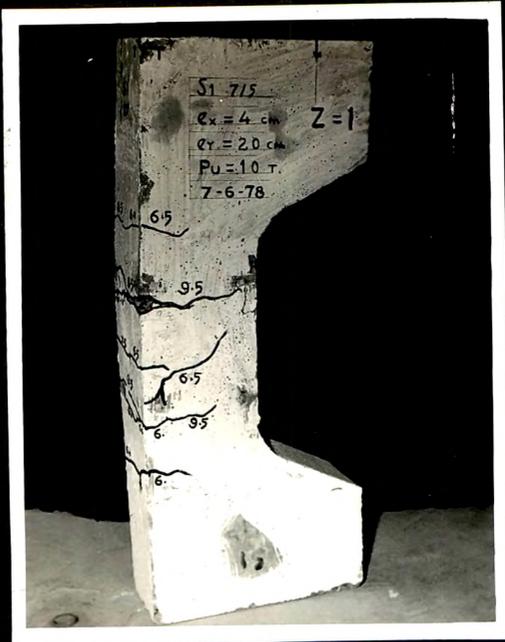
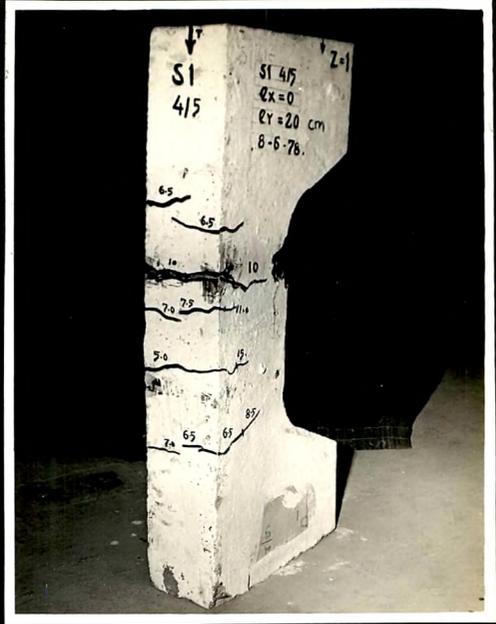
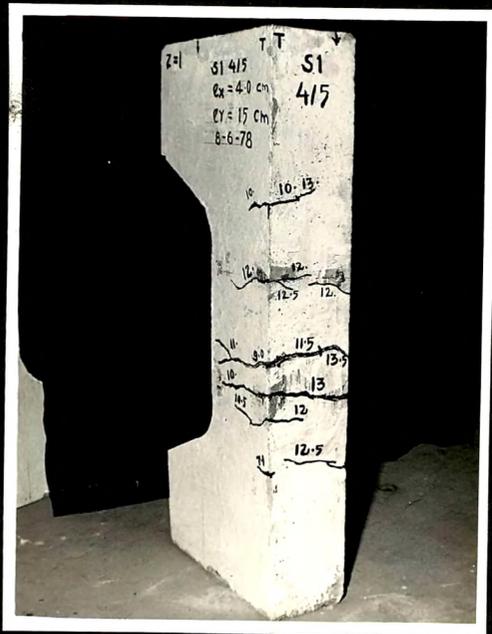
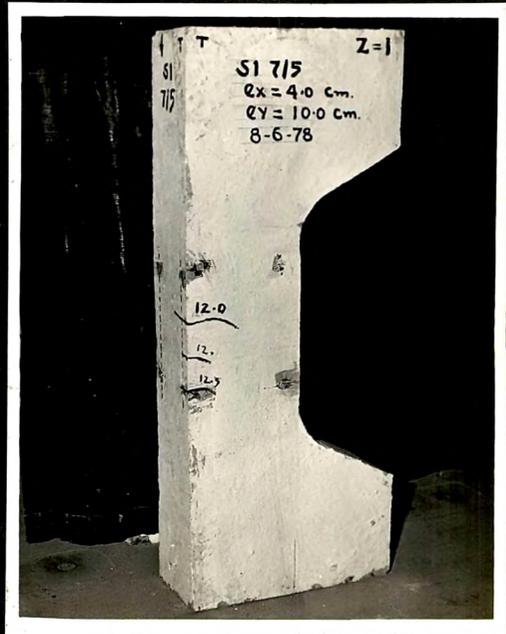
Plate Nos. 13 to 16
Crack Pattern ;
Specimen Nos. 13 to 16

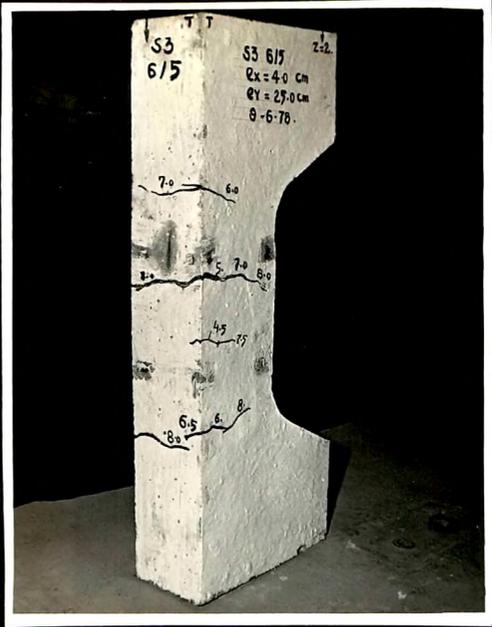
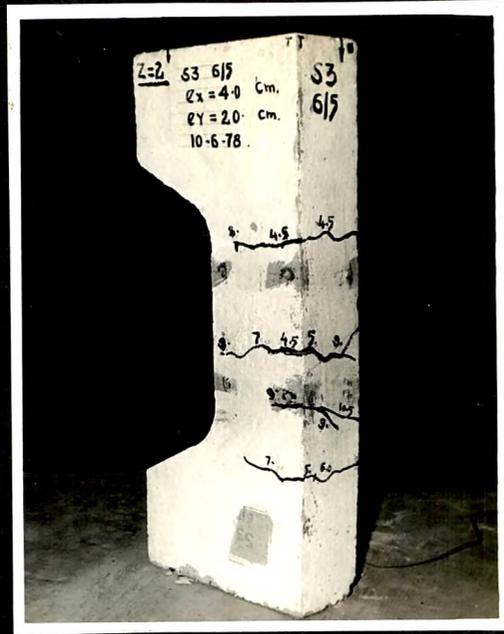
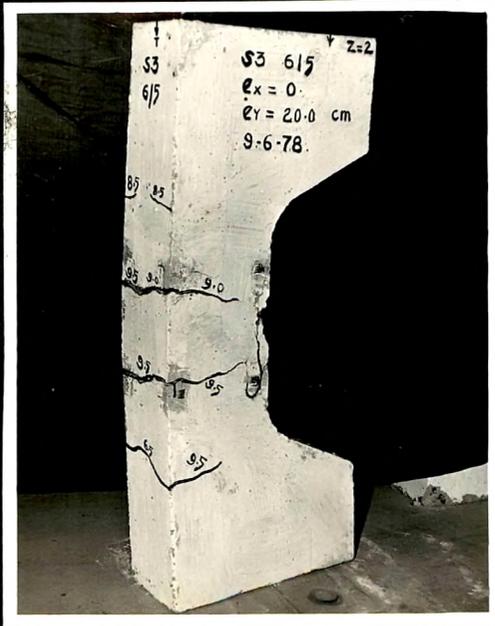
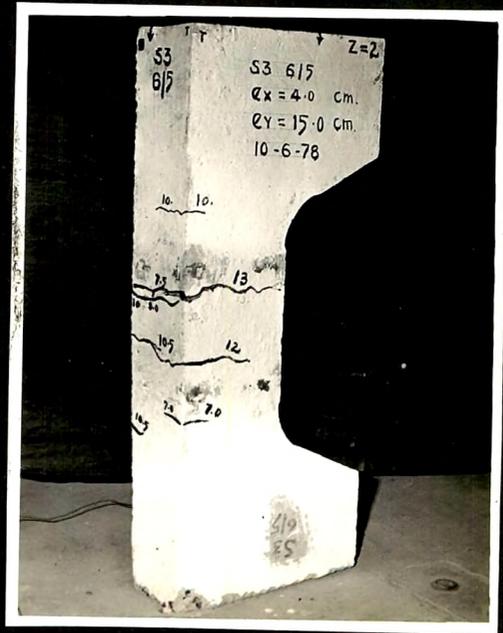
Plate Nos. 21 to 24
Crack Pattern ;
Specimen Nos. 21 to 24

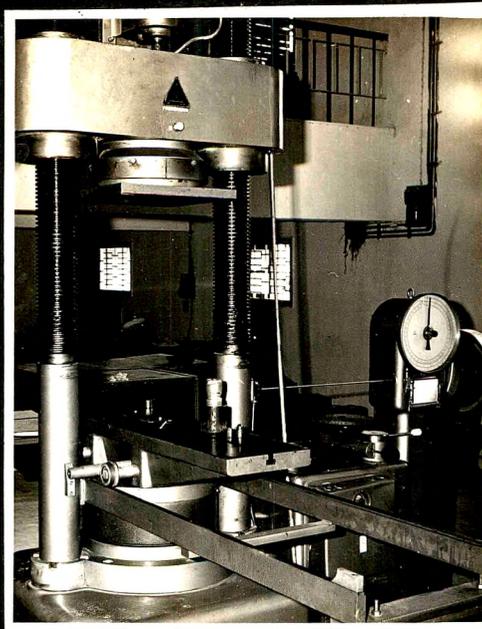
Plate No. 25
 Load Testing Machine : 200 T. Capacity :
 Hinge Device is seen on cradle

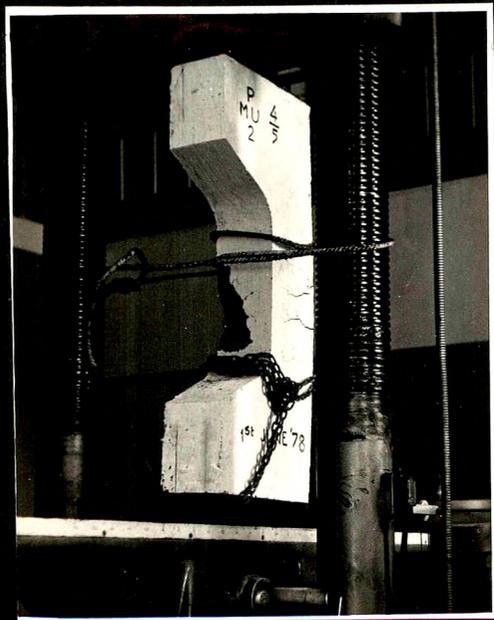
Plate No. 26
 Specimen MUP "2" 4/5 , on Testing Machine
 Specimen is seen mounted on hinge device

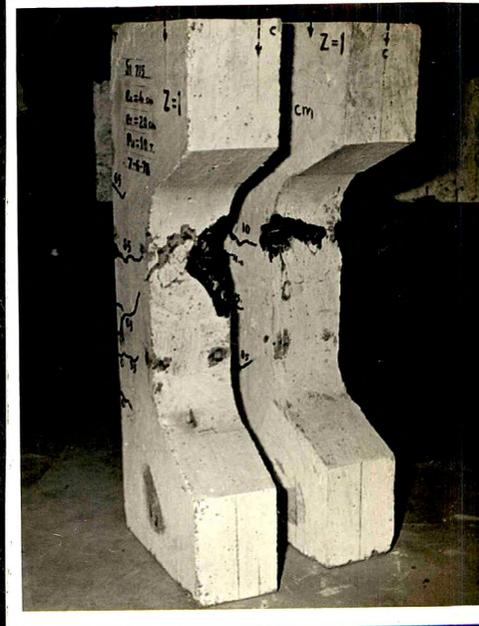
Plate No. 27
 Cracks on compression face and
 spalling of concrete : Specimens 13 and
